RESTORATION BY DESIGN

Great Bay Estuary, New Hampshire

Final report prepared by The Nature Conservancy for the U.S.
Department of Agriculture Natural Resources Conservation
Services.

Authors: Alix Laferriere & Brianna Group
January 2021

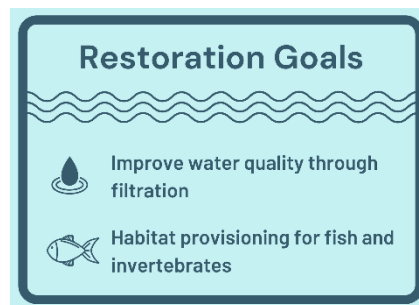
Figure 2. The Nature Conservancy in New Hampshire's ecological goals for oyster restoration: improving water quality through filtration, and habitat provisioning for fish and invertebrates by rebuilding important oyster reef habitat.

As ecosystem engineers, oysters and the reefs they form provide ecosystem services through physical structures and biological processes. Some valuable ecosystem services provided by oysters within the Great Bay system include creating habitat for various life history stages of native fish and invertebrates, removing excess nutrients from the water column through filtration, improving water clarity, removing nitrogen through tissue assimilation and denitrification on reef materials and in surrounding sediments, stabilizing sediment, sequestering carbon and buffering against ocean acidification (Grabowski and Peterson, 2007, Coen et al., 2007, Piehler and Smyth, 2011, zu Ermgassen et al., 2013a, zu Ermgassen et al., 2013). These services are also expressed as benefits to people such as an increase in recreational fishing due to increase in fish and invertebrate species associated with the reef, and progress towards mandated total maximum nitrogen loads through the tons of nitrogen removed through tissue assimilation or denitrification (Higgins et al. 2011; Rose et al. 2014; Bricker et al. 2020). Two main ecosystem services drive the focus of our restoration work in the Great Bay Estuary (Figure 2).

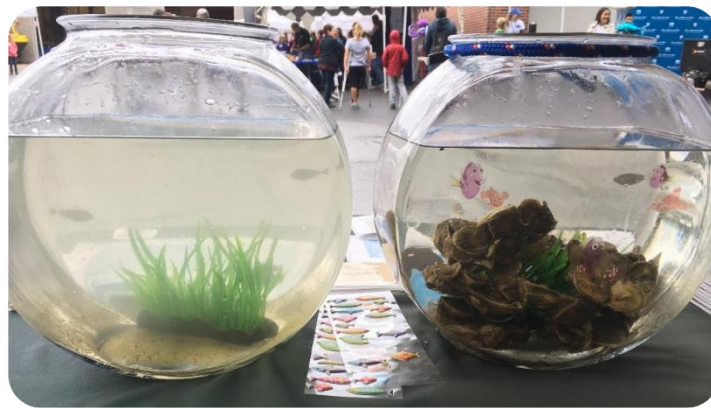
Figure 3. Two tanks containing Great Bay estuary water at an outreach event showing the results of live oysters filter feeding over the course of an hour. Tank on the right contains live oysters, while the tank on the left does not.

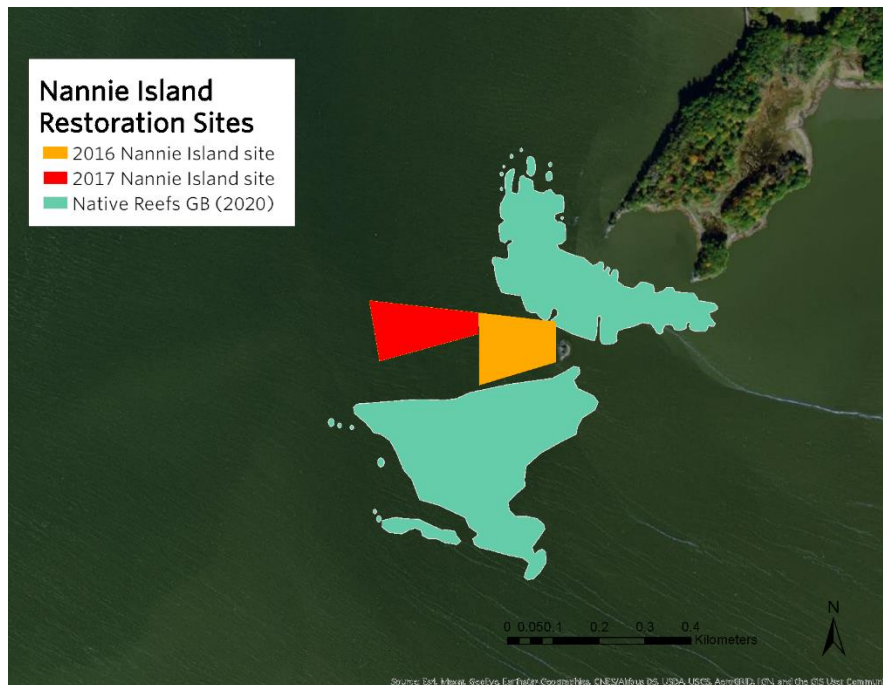
Figure 7. Close up of the Nannie Island 2016 and 2017 restoration sites (red and orange) compared to the native Woodman Point (upper) and Nannie Island reefs (lower) (turquoise).

The 5-acre site was designed to be juxtaposed with the native oyster reef at Nannie Island and the 2016 restoration site (Figure 7). Prior to shell placement the site was surveyed on June 16 and 21, 2017 with underwater video to characterize bottom conditions and confirm no eelgrass was present at the site. Additionally, Dr. Lippmann of UNH CCOM provided high-resolution bathymetry data from a sonar survey of the site (section bathymetric mapping). The video classification was overlaid on the bathymetric

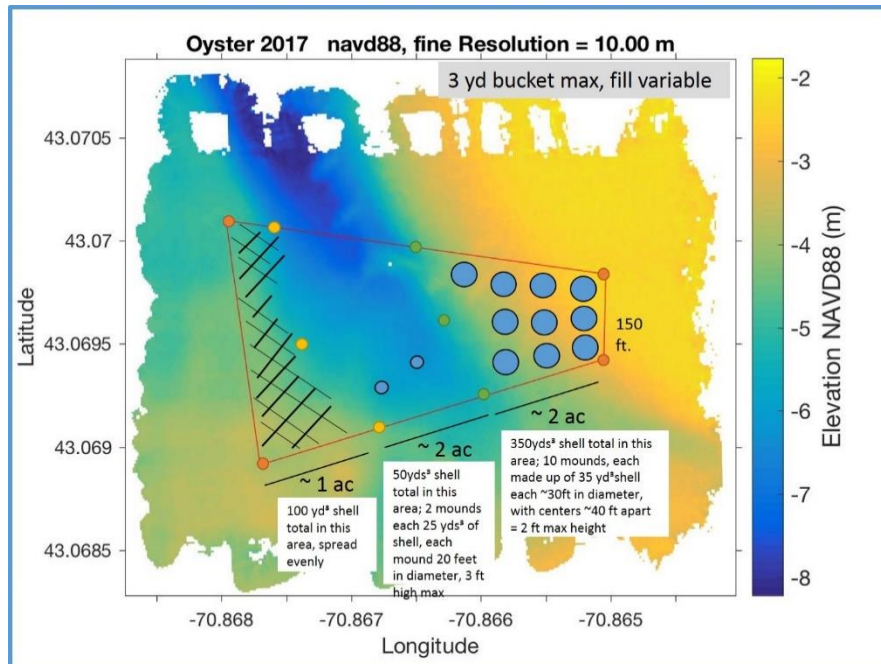
Figure 8: Mollusc shell deployment plan provided to the marine contractor projected onto multibeam sonar bathymetry map. Note that the shell base consisted of a total of 12 individual shell mounds and a thin layer of shell to be distributed in the cross-hatched area (Taken from Grizzle & Ward, 2018)

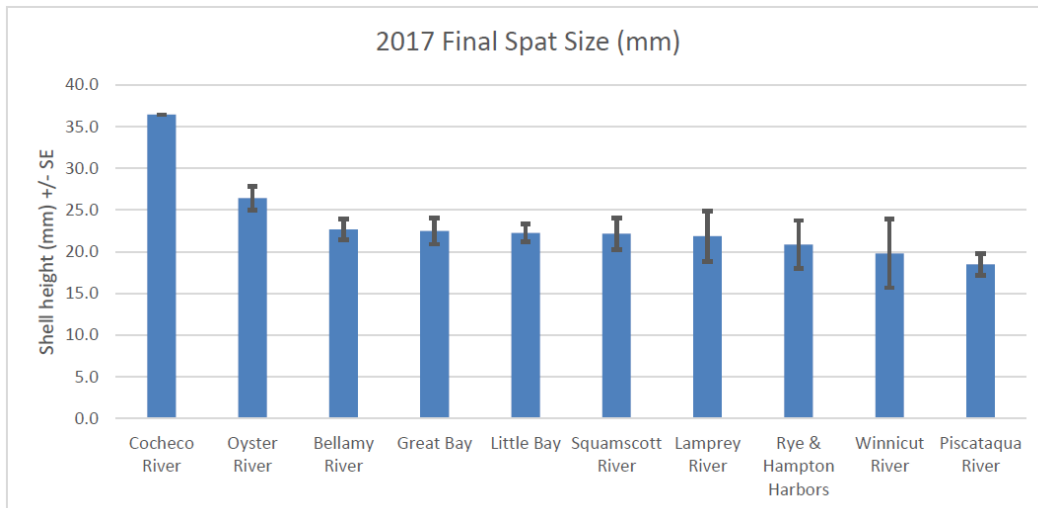
Figure 12. Average final size of oyster SOS (mm) based on location, 2017 ± SE. (Moeser, 2017 Oyster Conservationist Report).

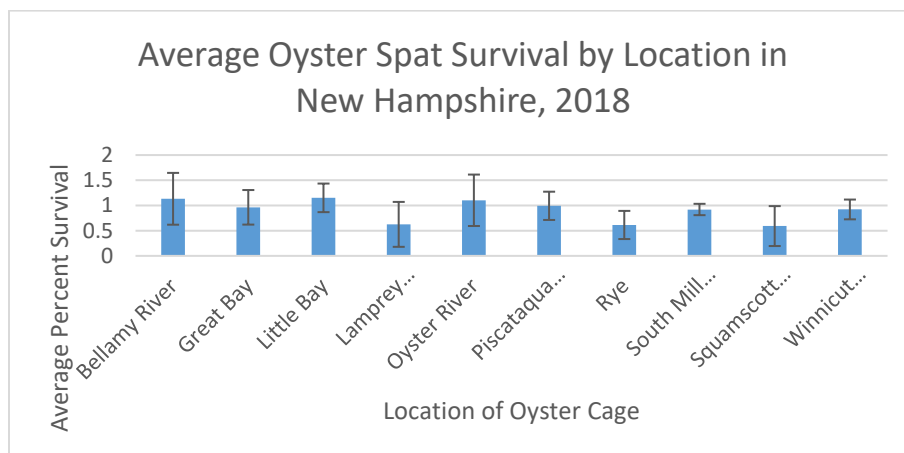
Figure 15. Average percent of oyster survival (± SE) in 2018 by location. Survival over 100% can be attributed to settlement of wild spat in the OC cages (Group, 2018 Oyster Conservationist Report).

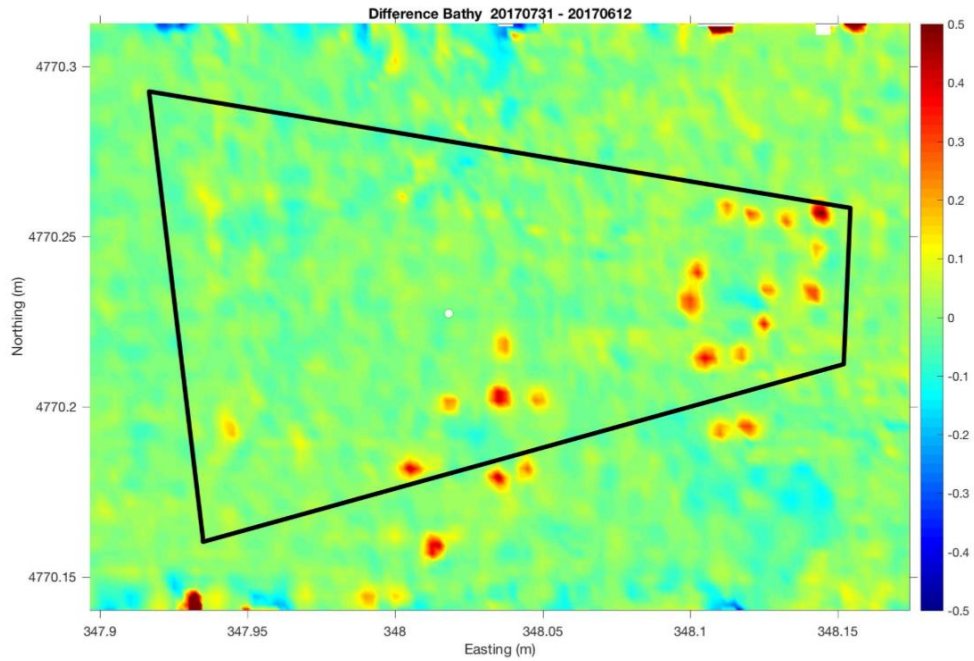
Figure 16. Difference elevation map between surveys obtained at Nannie Island on 12 June and 31 July 2017. Locations of deployed oyster shells are easily identified by elevated mounds (reddish colors). Horizontal resolution is 25 cm. Elevation differences are in m and given by the colorbar on the right-hand-side. Horizontal coordinates are km in eastings and northings. The solid black line outlines the region encompassing the 5-acre artificial oyster reef region (Taken from Lippmann, 2019).

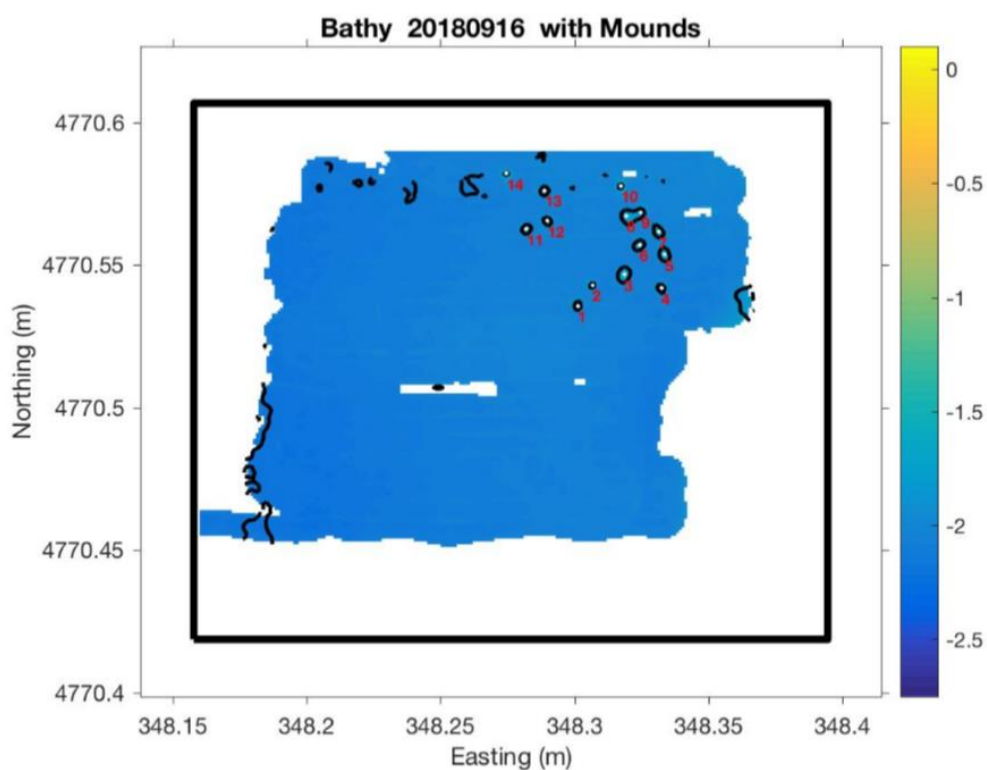
Figure 18: Bathymetric map of Woodman Pt. obtained on 16 September 2018 also showing the outlined regions of the oyster mounds identified by the difference map (Figure 13). Locations of mound elevation maxima are indicated with white dots within the contours. Mounds are numbered from 1 to 14. Background bathymetry has resolution of 1.0 m. Elevations are in m relative to NAVD88 (approximately mean sea level) and given by the colorbar on the right-hand side. Horizontal coordinates are km in eastings and northings (Taken from Lippmann 2019).

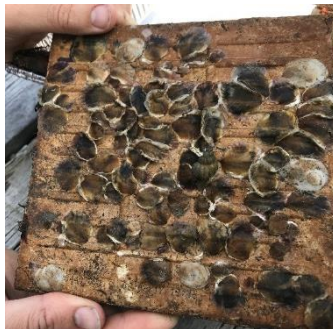
Figure 34. A tile used in the 2018 recruitment study taken from Nannie Island restored site covered in oyster spat.

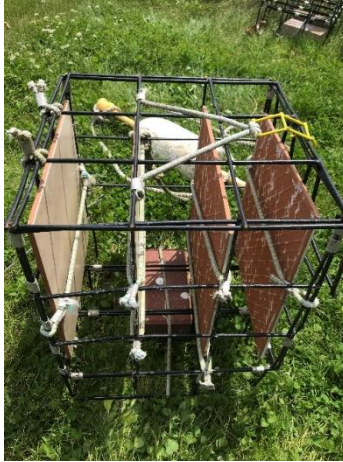
Figure 35. Recruitment device used in 2019 and 2020. Each device contains 4 tiles and is held in place with bricks and attached to a buoy.

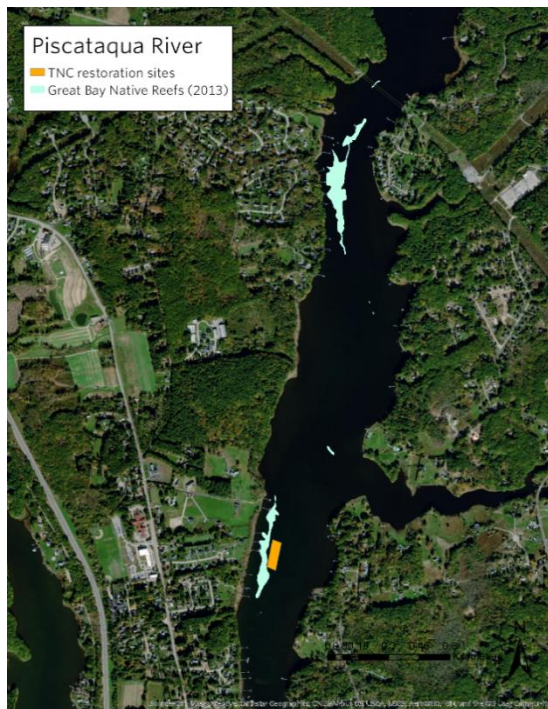
Figure 40. TNC reef restoration from 2013 (orange) shown abutting the native reef (blue). This mapping was conducted in 2013 and would need to be updated before any further restoration work was completed.

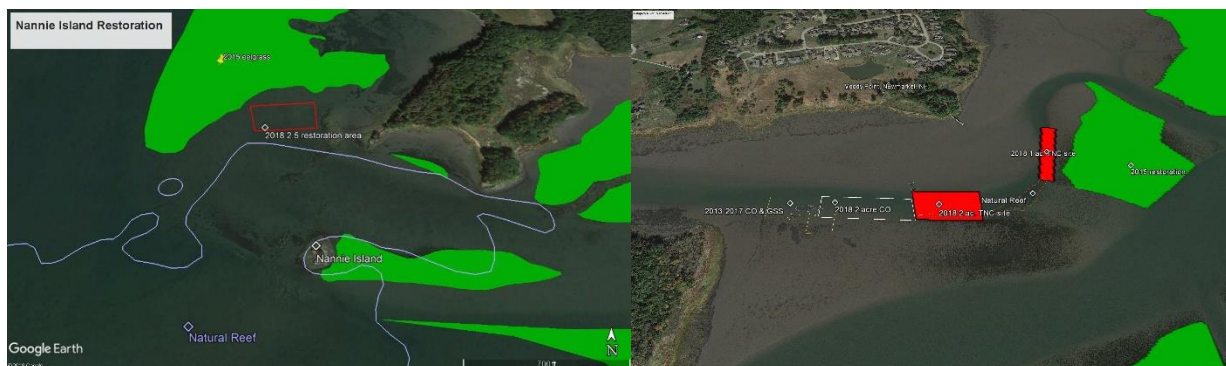
Figure 2. Maps of the 2018 restoration regions. Left panel shows the Woodman Pt. 2.5 acre region outlined in red. Right panel shows the north (1 acre) and south (2 acre) restoration regions (in red) near the mouth of the Lamprey River. Also shown on the right is the outline of the 1 acre Lamprey River natural reef (in between the red restoration areas) that was surveyed on 03 August 2018 as part of the NCRS drilling activities. Figures courtesy of Ray Grizzle and Krystin Ward, UNH.

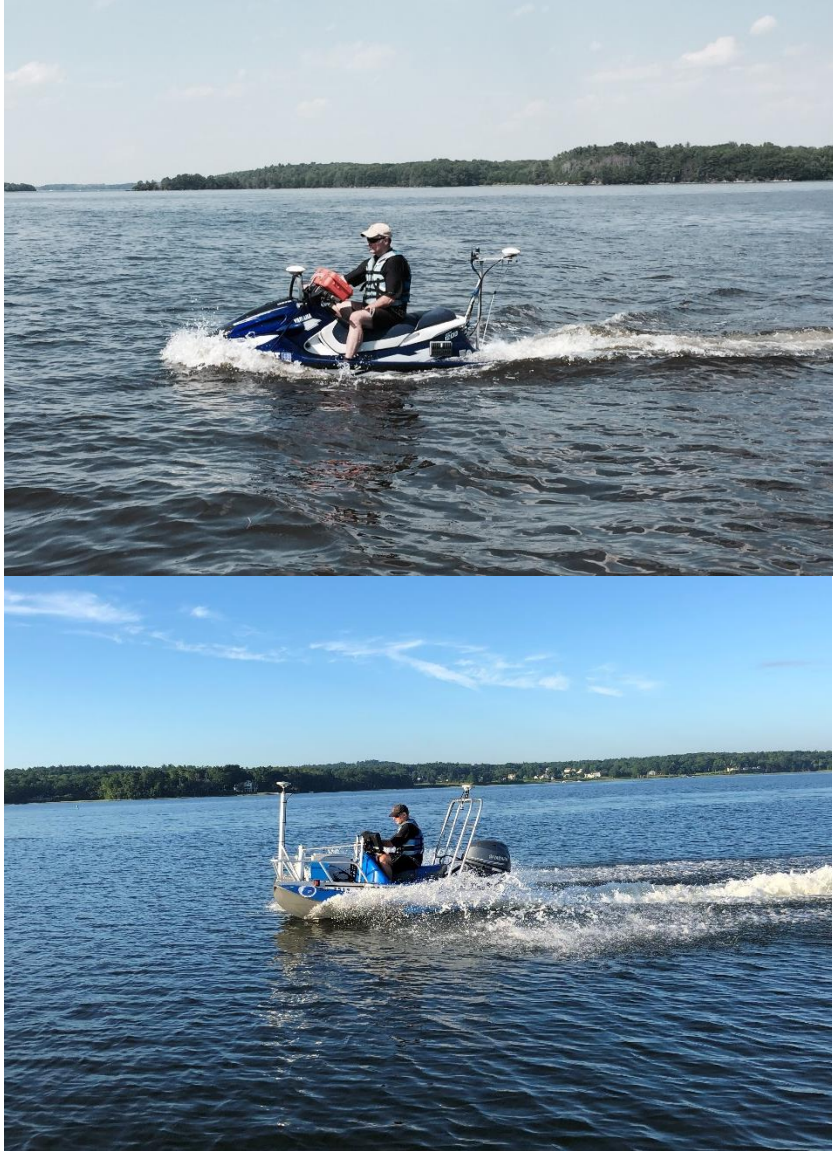
Figure 3. Picture of the CBASS (top) during survey on 12 June 2017, and Zego Boat (bottom) during survey conducted on 03 August 2018.

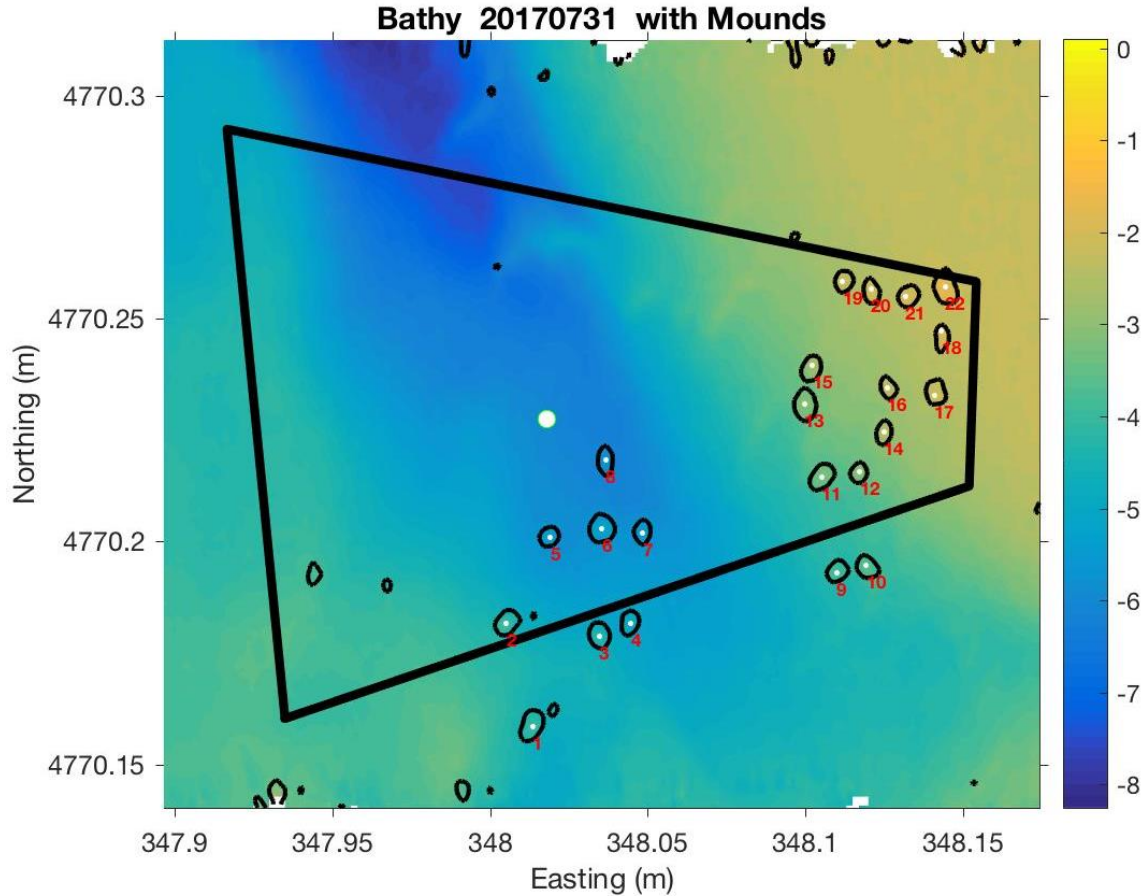
Figure 8. Bathymetric map from 31 July 2017 showing the outlined regions of the oyster mounds identified by the difference map (Figure 8). Locations of mound elevation maxima are indicated with white dots within the contours. Mounds are numbered from 1 to 22. Background bathymetry has 1.0 *m* resolution. Elevations are in *m* relative to NAVD88 (approximately mean sea level) and given by the colorbar on the right-hand-side. Horizontal coordinates are *km* in eastings and northings. The solid black line outlines the region encompassing the 5-acre artificial oyster reef region. White dot indicates the location of the ADCP deployed in 2018.
